Evaluation of the Dropping of a Propeller Shaft During Installation on the USS COLE a DDG 51 Class Destroyer

LT Phillip Burnside
United States Naval Reserve.

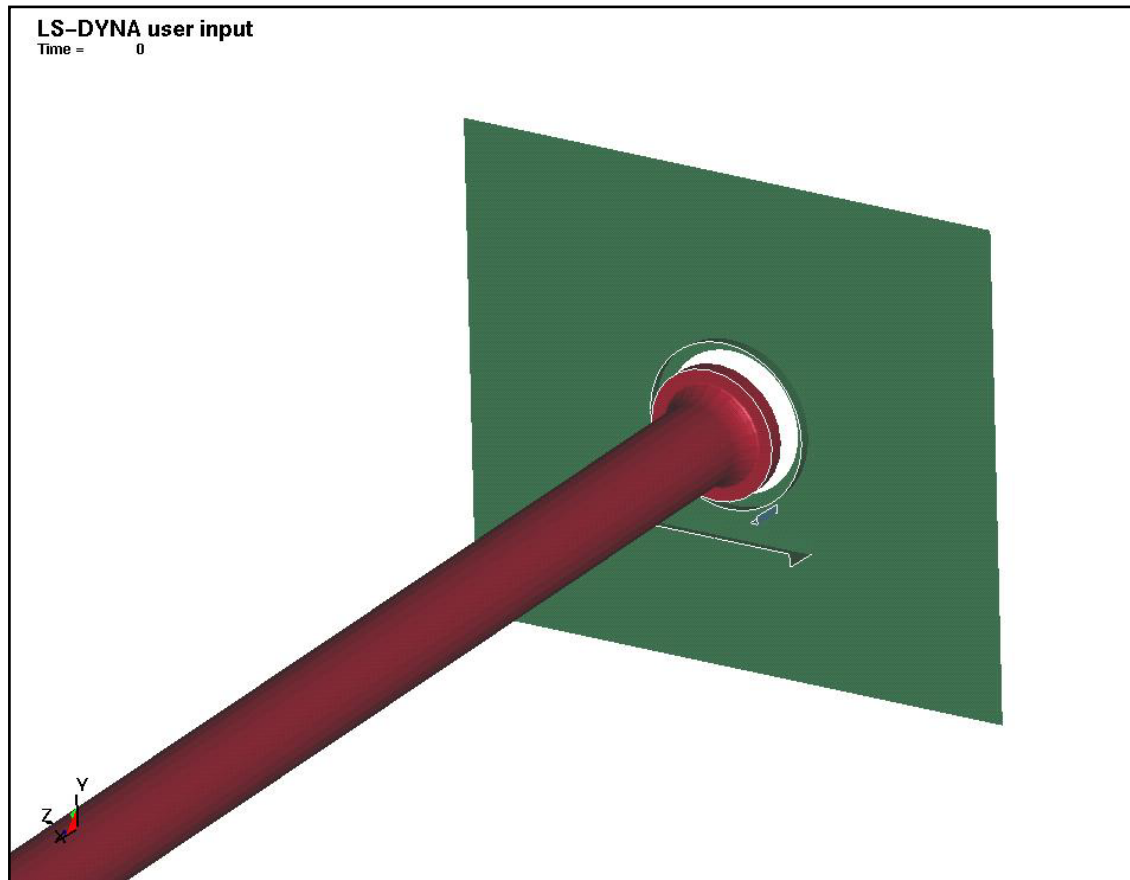
After the incident, observations were made of the damages to the all of the components. The C channel that was temporarily welded to the bulkhead was permanently deformed three inches. In addition, a piece of two-inch angle welded perpendicular to the bulkhead was also flattened against the bulkhead by the shaft. Visual inspections of the shaft indicated that it was OK. However, the inspection was limited due to the fact that the shaft was already inside the ship.

Model of the shaft section that was dropped and the bulkhead it landed on.
Figure 2

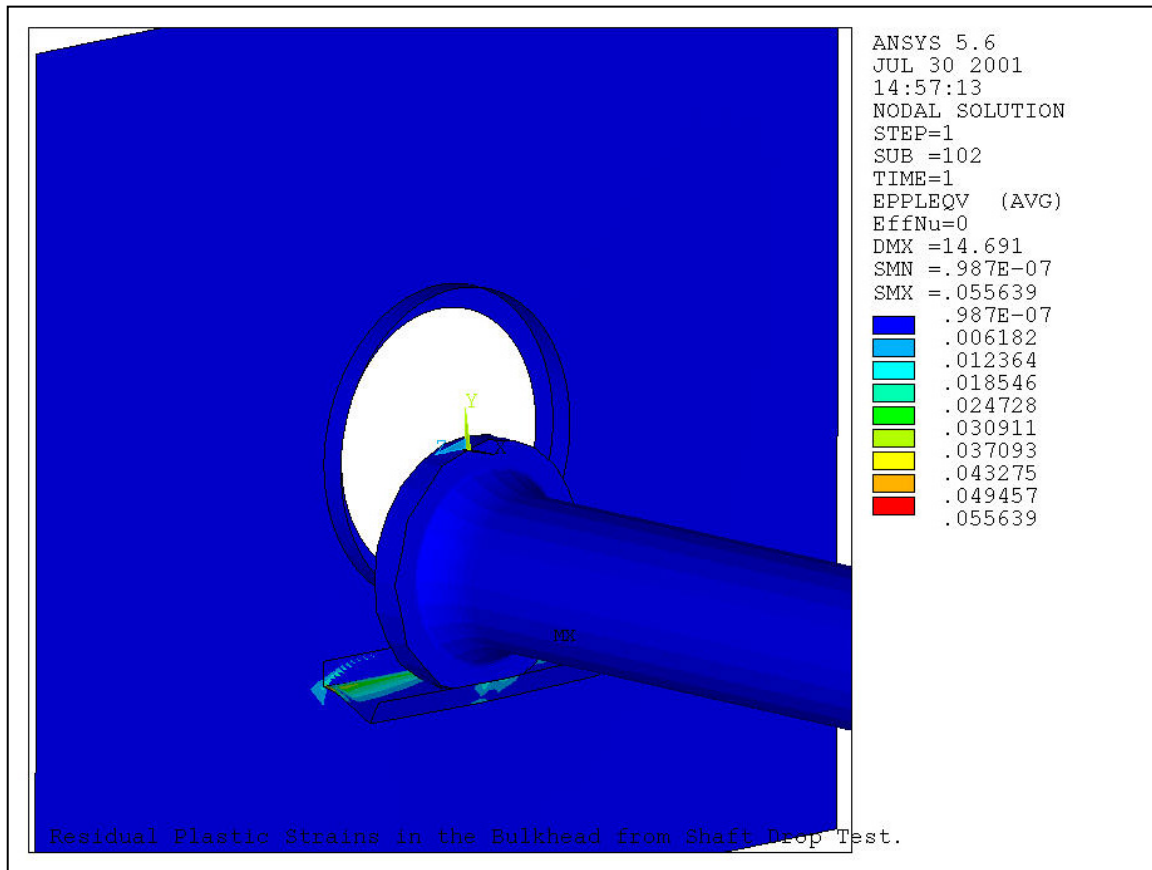
Figure 4.

The Model of the shaft drop illustrated that the shaft was not damaged in the incident. The bulkhead and C channel that the shaft landed on absorbed the energy of the impact. In fact the C channel was deformed 3.1 inches in the simulation while the on site observations showed a 3-inch deformation. This basic observation provided the basic validation of the model to the Naval personnel that it was safe to install the shaft and test it 30 days later after the shaft was fully installed and could be NDT while being turned to provide the final proof that the shaft was safe for use at maximum load conditions. The results of the model are illustrated in figure 4.

Plastic Strains illustrate that the bulkhead was damaged but the shaft section was not damaged from the being dropped.

In addition, in order to determine if permanent damage was done to the shaft section a bi-linear post yield material model used in LS-DYNA model as illustrated in figure 3. In addition the standard kinematics Hardening law was used to determine residual strains that would be left if the metal went plastic. It is noted that this law was used since any plastic strains in the shaft would be cause for failure of the shaft section that would require it's replacement. And therefore the failure criteria is any plastic strains in the shaft section would indicate that the shaft section was not acceptable for use in the USS COLE. In addition, since the bulkhead could be replaced/repaired plastic deformation was accepted. Any areas that were identified as damaged would be heat straightened after the temporary brackets were removed.
