Highly Advanced M&S System for Marine Accident Cause Investigation using FSI Analysis Technique

Sang-Gab Lee, Jae-Seok Lee, Hwan-Soo Lee

Korea Maritime & Ocean University, Marine Safety Technology

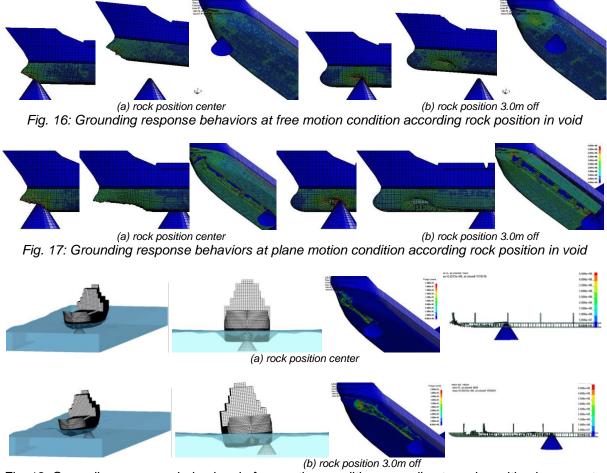
Fig. 18: Grounding response behaviors in free motion condition according to rock position in sea water

Contrary to the void condition, more realistic grounding response behaviors of the grounding ship, such as jumping and sway around the rock under the self-weight of grounding ship, could be found depending on the load condition and rock height and position using FSI analysis technique. There was no damage in the inner hull of the grounding ship in any grounding scenario in this study except very small stress concentration in the inner bottom hull in the case of full load condition with rock height 2.0m and center position. This might be due to the double bottom structure with good combination of longitudinal and transverse girder members.

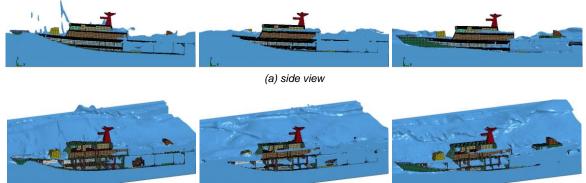
Fig. 27: Inflow of seawater through openings of deck and superstructure and propagation to accommodation compartments

Figures $25 \sim 26$ show the breaking wave response behaviors to the ship and quay and ship motion, depending on the breakage of the rear ropes at the second step. As the seawater flooded in the inboard of the ship, the rear of the ship trimmed by the stern more and moved more vertically and laterally, and the 5th, 6th and 4th ropes were cut off one by one with the increase of their tensile strengths, where the rear of the ship rolled out more to the starboard, as shown in Figs. 25~26. Seawater flowed through the doors of superstructure and through the openings of the deck, and propagated through the openings of the watertight bulkheads to the accommodation compartments, as shown in Fig. 27. Breaking wave also swept over the forecastle deck and seawater also flowed through the openings of the forecastle deck into the inboard compartments.

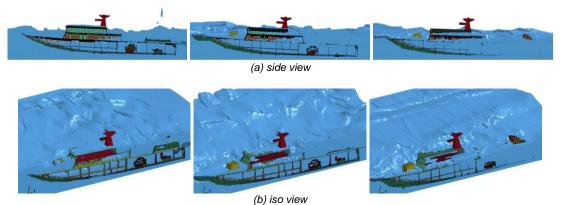
Fig. 29: Inflow of seawater through doors of superstructure and sink down to bottom

At the final step, Fig. 28 shows the breaking wave response behavior to the ship and quay, where the ship sank down more and rolled out more to the starboard. After seawater was flooded in the most compartments under the main deck, seawater flowed through the doors of the superstructure, as shown in Fig. 29, and the ship sank down more and the rear starboard bottom touched to the bottom. Through the full-scale ship flooding and sinking simulation using FSI analysis technique and realizing the rough sea condition, such as breaking wave, flooding and sink accident procedure could be investigated with high accuracy.

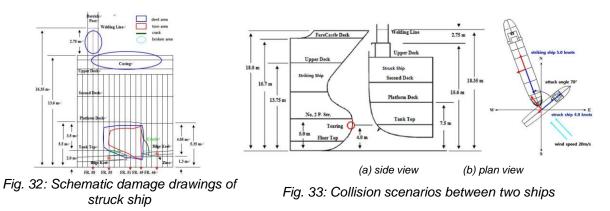
Schematic damage drawings were summarized from these damage configurations in Fig. 32. From the investigation of all collision damage information, a collision scenario between the two ships was sketched, as shown in Fig. 33(a). Fig. 33(b) depicts one collision scenario in a plan view among several ones, considering several attack angles, their speeds, and wind speeds and directions.
