# A Summary of the Space Shuttle Columbia Tragedy and the Use of LS-DYNA in the Accident Investigation and Return to Flight Efforts

## Abstract

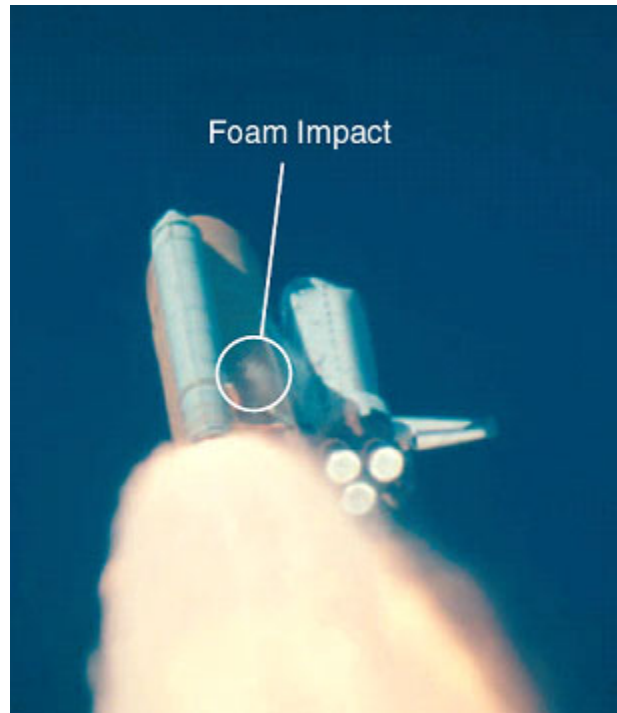
Figure 1. Debris cloud resulting from External Tank foam impact on Orbiter left wing leading edge.

On January 16, 2003, at 10:39 a.m. Eastern Standard Time, the Space Shuttle Columbia lifted off from Launch Complex 39-A at Kennedy Space Center in Florida. At approximately 82 seconds into launch, Columbia was traveling at Mach 2.46 (1,650 miles per hour) at an altitude of nearly 66,000 feet when it was struck by a large piece of foam that had separated from the shuttle's external fuel tank. The foam, decelerated by the air flow past the Orbiter, struck the left wing leading edge of Columbia at a relative speed of 416 to 573 miles per hour causing the breach in the leading edge thermal protection system that ultimately led to the tragedy. Two movie cameras captured the event. Figure 1 is an image taken from one of the movies just after the event that depicts the particle cloud of foam resulting from the impact.

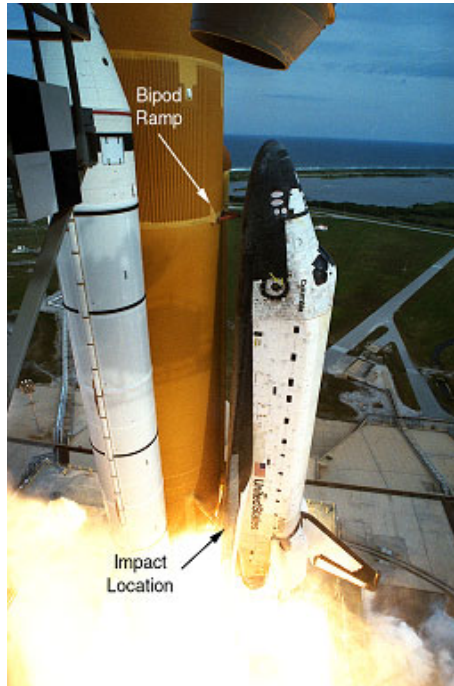
Figure 2. Shuttle Columbia just after liftoff showing the Bipod Attachment, the Bipod Ramp and the location of Impact.

The Orbiter is attached to the External Tank at three locations: Two support points at the rear of the vehicle, and one at the front, which is referred to as the Bipod. The Bipod consists of two struts connecting the front of the orbiter to the ET. The Bipod attachment at the ET requires additional insulation which is applied in the shape of a ramp to account for aerodynamics. This foam build-up is referred to as the Bipod Ramp. Figure 2 highlights the Bipod, the Bipod Ramp, and the general impact location on Columbia's left wing leading edge.

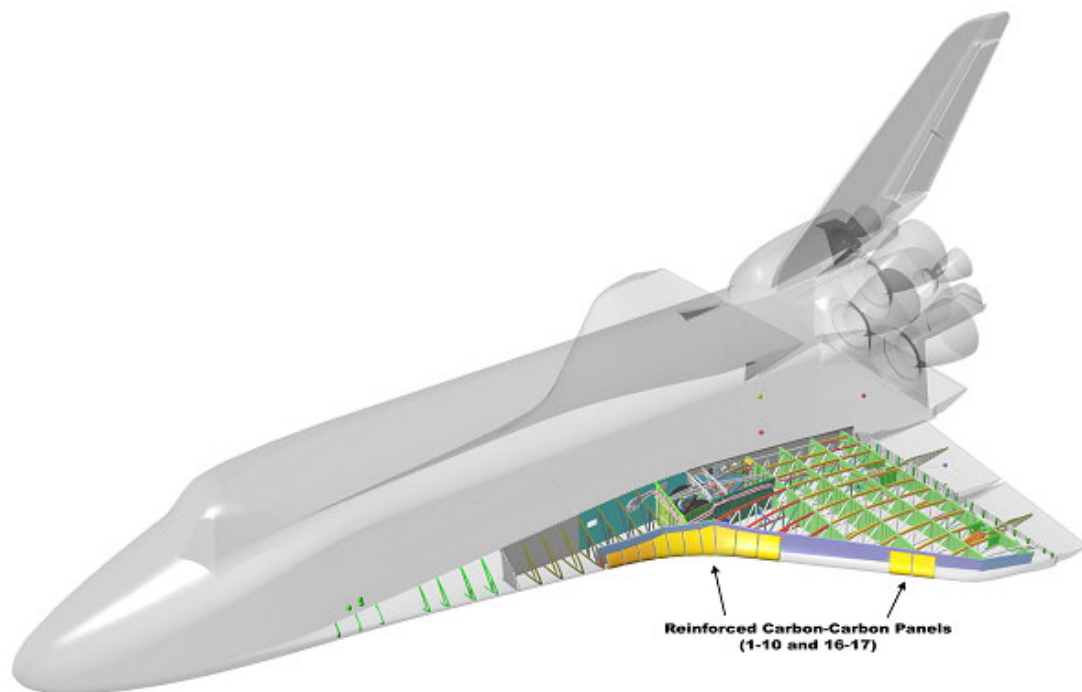
Figure 3. Reinforced Carbon-Carbon panels (in yellow) are attached on the Orbiter leading edges.

Each orbiter wing has 22 unique panels made by hand for its specific location on the wing. The gaps between these panels are sealed with a structure, also made of RCC, called a T-Seal. Figure 3 shows a graphic of several panels on an orbiter wing leading edge spar, and Figure 4 provides a closer view of a single leading edge panel with a T-Seal.

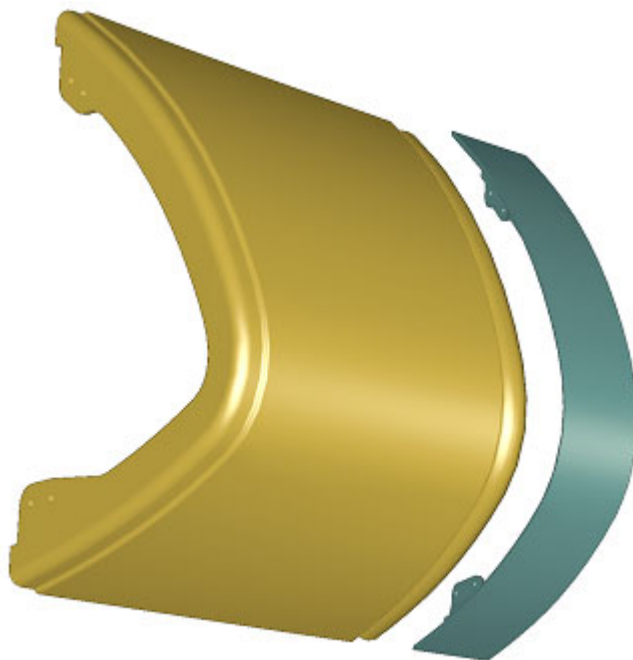
Figure 4. Reinforced Carbon-Carbon panel (in yellow) shown with T-Seal (in blue).

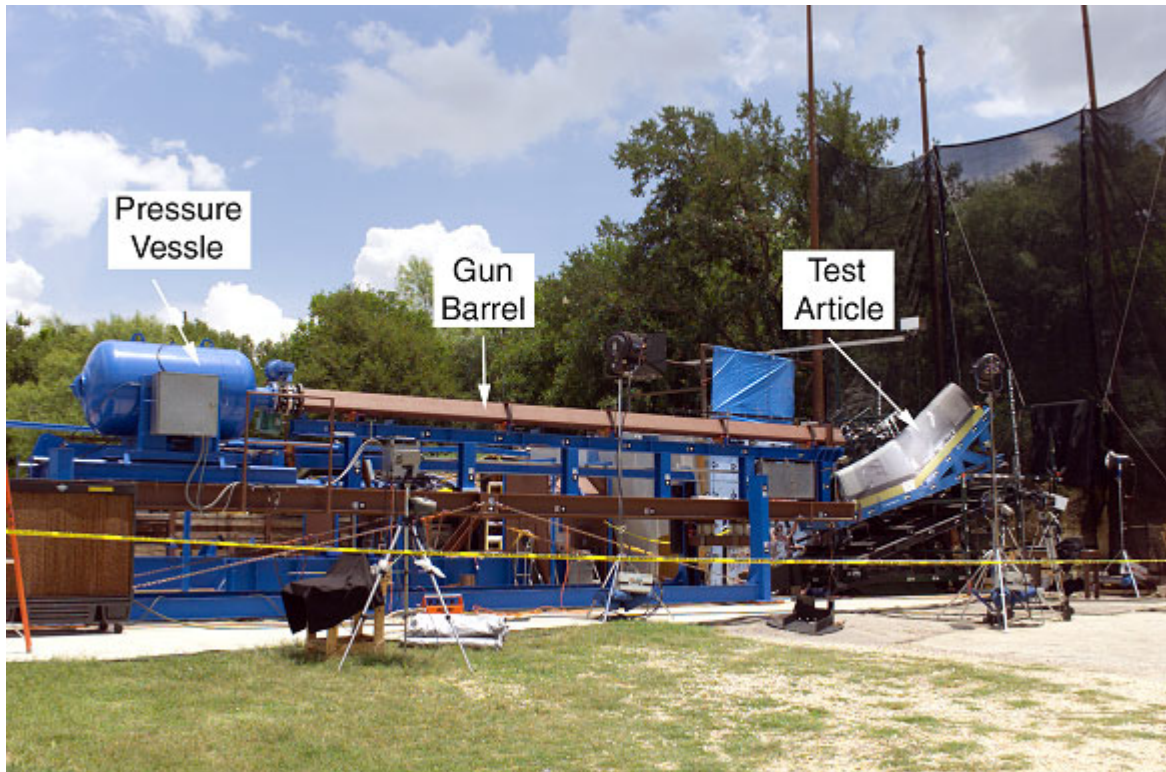
Figure 5. Ballistic test range at Southwest Research Institute showing gas gun and full-scale Orbiter leading edge test article.

Once it was determined that ET foam debris from the Bipod Ramp was a likely cause of the leading edge breach, the CAIB [1] began an aggressive test program at Southwest Research Institute (SwRI) to build a full-scale test article of a segment of an Orbiter leading edge for impact testing. RCC panels from the remaining Orbiters that had similar mission histories to those on Columbia were used for the testing. Figures 5 and 6 show the test range and the full-scale test article, respectively, at SwRI.

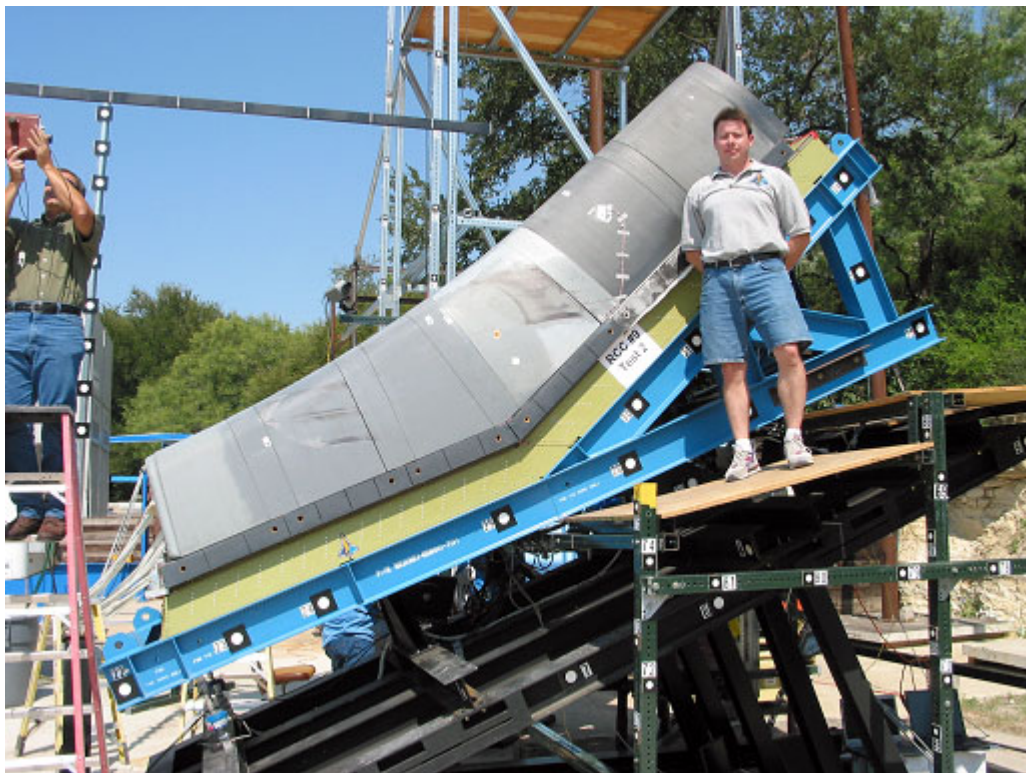
Figure 6. Full-scale Orbiter leading edge test article at Southwest Research Institute ballistic range.

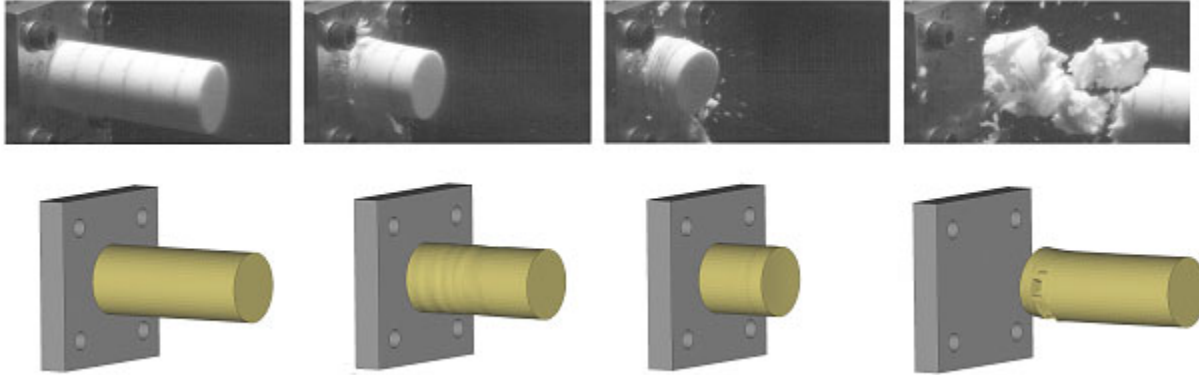
Figure 7. Comparison of foam ballistic impact tests with LS-DYNA predictions.

The material model for the BX-250 foam was developed out of static and dynamic testing as well as sub-scale impact tests on load cells [2]. Figure 7 shows the comparison of a BX-250 impact test on an aluminum plate as compared with the LS-DYNA prediction. The RCC composite material model was initially based on limited static stress-strain data. Current work is underway to determine high strain rate behavior for RCC to enhance the model. References 2 and 3, presented in these proceedings, highlight this work in detail.

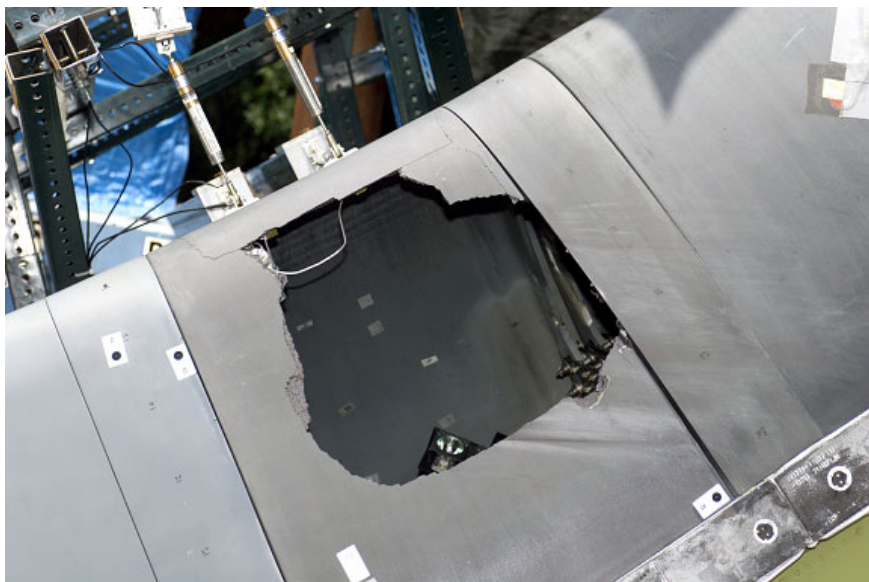
The most significant full-scale leading edge test performed by the CAIB was that on Panel 8. In this test, a 1.67 pound piece of foam was shot at 775 feet per second at panel 8. The impact created a hole in the panel sixteen inches square, which can be seen in Figure 8. LS-DYNA analysis predicted a similar hole for those test conditions. This is shown correlated in Figure 9 compared with stills taken from high speed digital photography taken during the test. In addition to the panel 8 test, LS-DYNA was used extensively throughout the full-scale test series to provide assistance in establishing test velocities, projectile sizes, and aim points for each test [6].

Figure 8. Hole in RCC Panel 8 created by foam impact test at Southwest Research Institute.

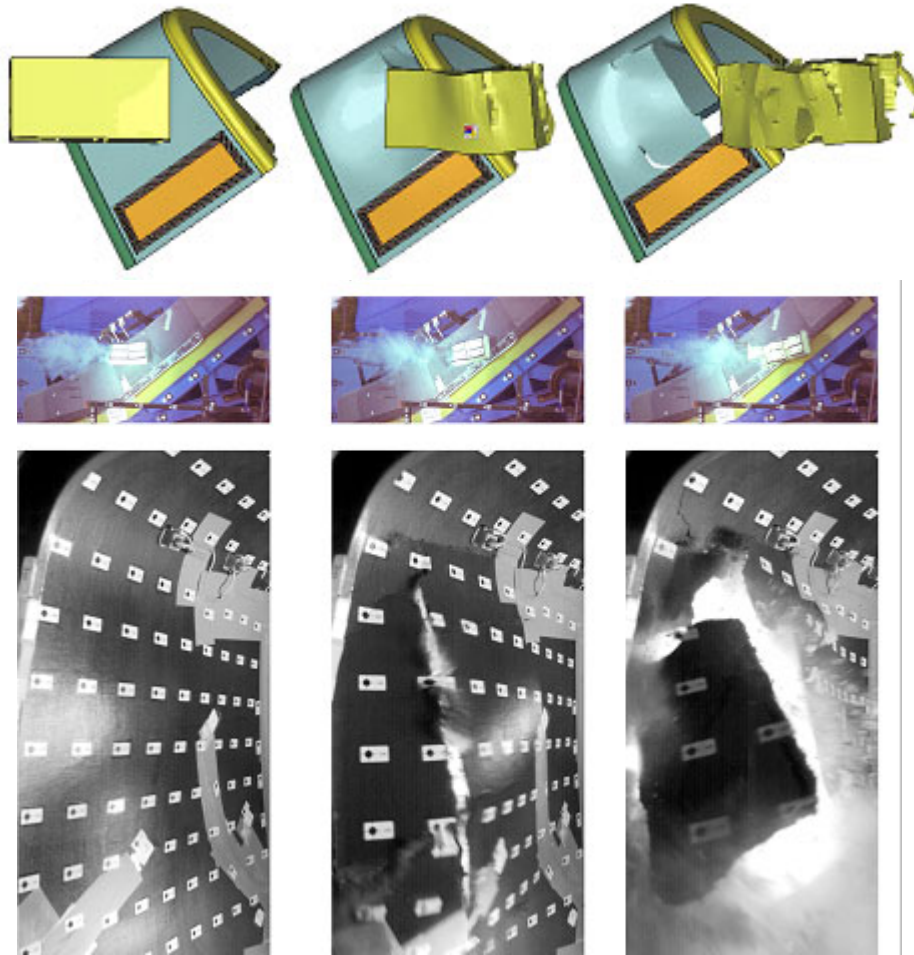
Figure 9. LS-DYNA predictions of Orbiter panel 8 full-scale leading edge test with images from high-speed digital video taken from actual tests.
