Evaluation of the Dropping of a Propeller Shaft During Installation on the USS COLE a DDG 51 Class Destroyer

LT Phillip Burnside
United States Naval Reserve.

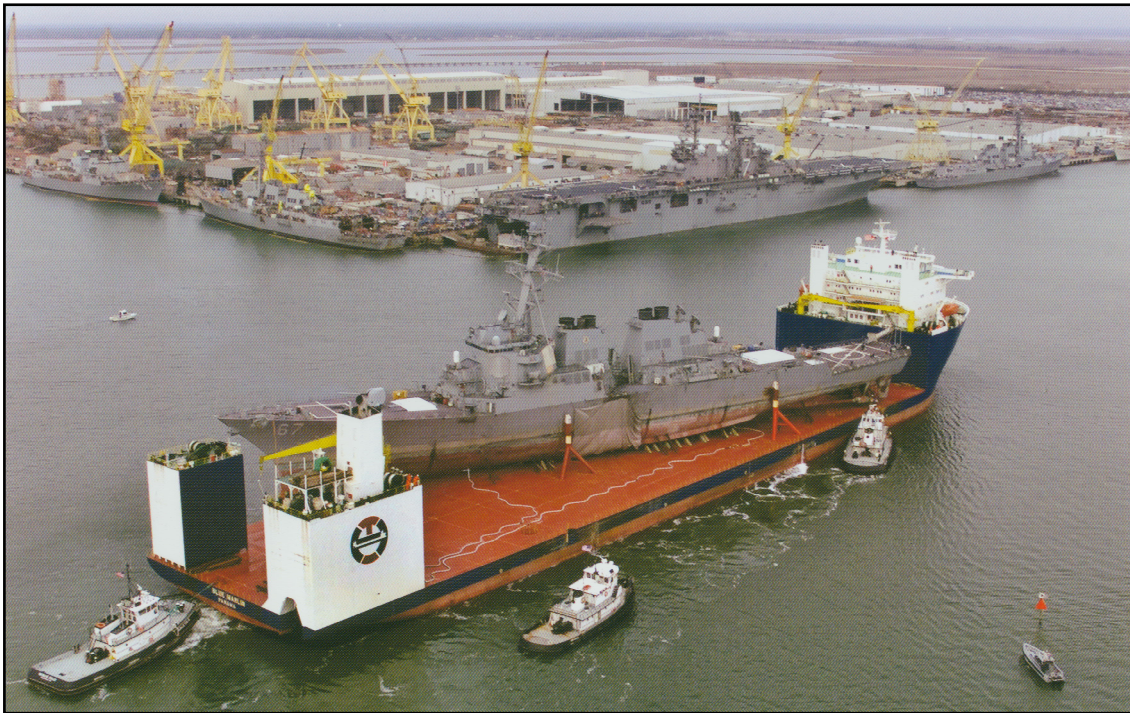
The USS COLE arriving in Pascagoula, MS to be repaired. (Courtesy of Ingalls Shipbuilding)
Figure 1

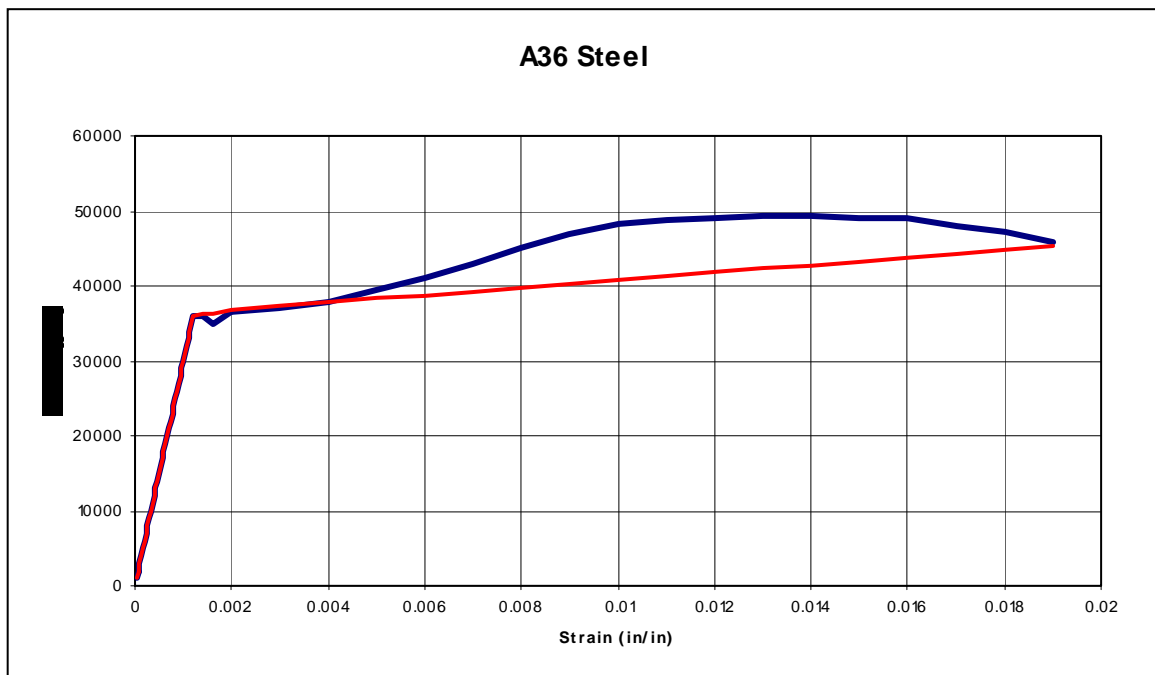
Figure 3.

In addition, in order to determine if permanent damage was done to the shaft section a bi-linear post yield material model used in LS-DYNA model as illustrated in figure 3. In addition the standard kinematics Hardening law was used to determine residual strains that would be left if the metal went plastic. It is noted that this law was used since any plastic strains in the shaft would be cause for failure of the shaft section that would require it's replacement. And therefore the failure criteria is any plastic strains in the shaft section would indicate that the shaft section was not acceptable for use in the USS COLE. In addition, since the bulkhead could be replaced/repaired plastic deformation was accepted. Any areas that were identified as damaged would be heat straightened after the temporary brackets were removed.

Graph of A36 Steel Material Data and the Bi-Linear Model being used.

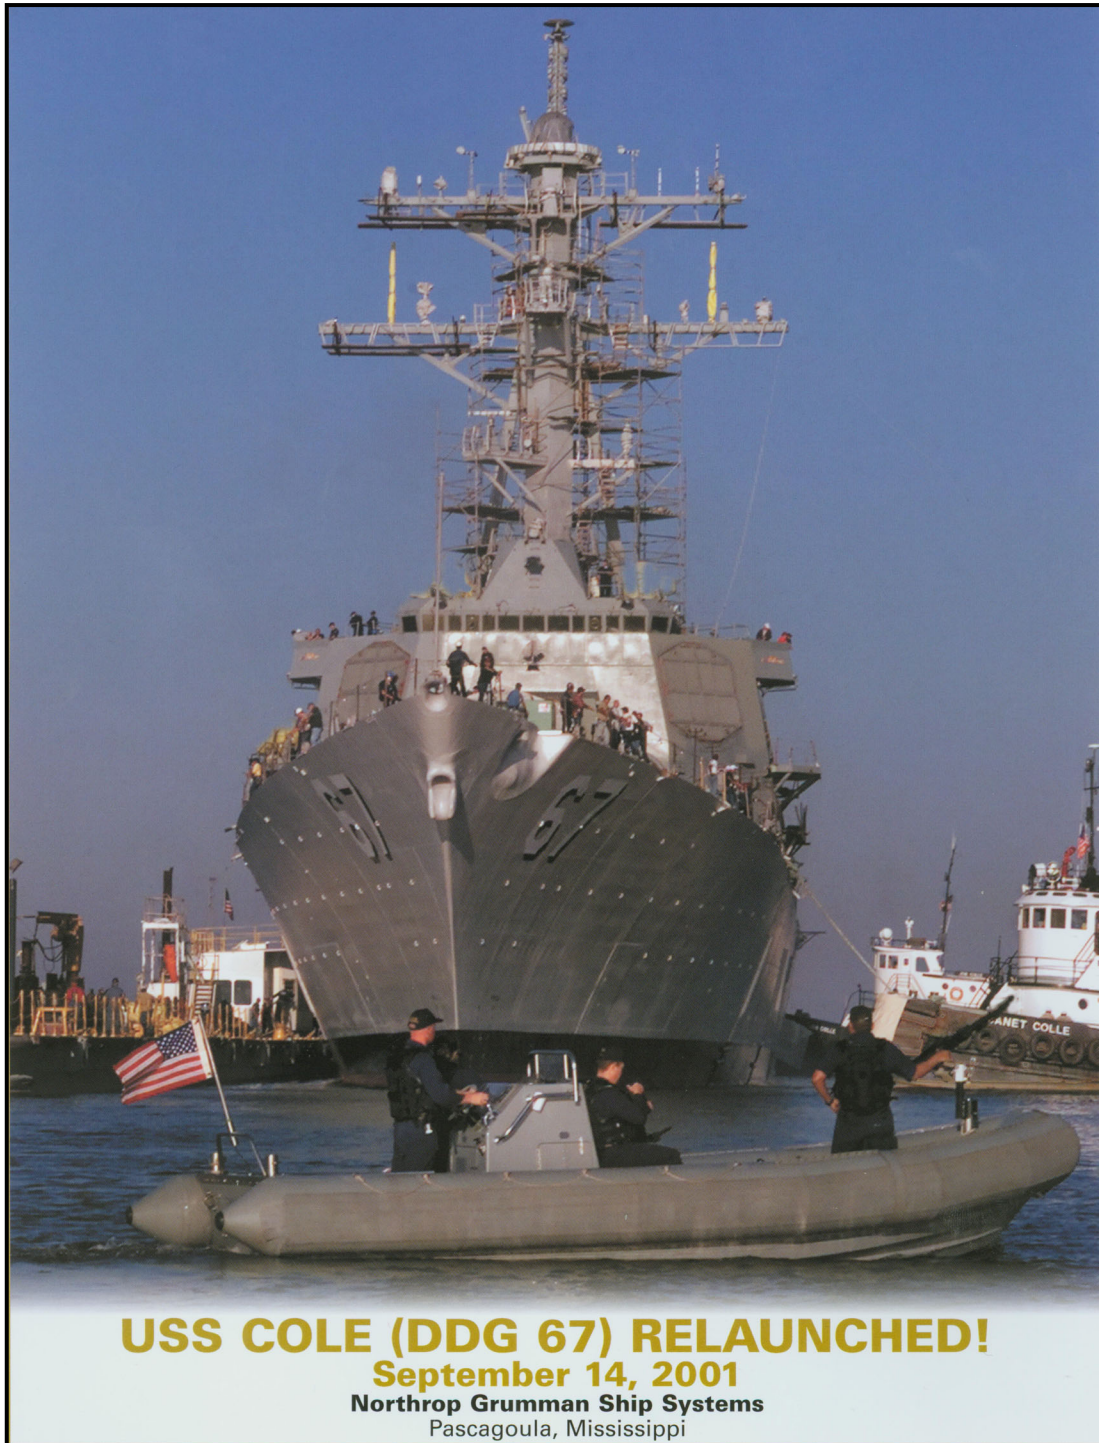
Since the only significant damage was to some temporary brackets that could be easily replaced the repair schedule was maintained per the Chief of Naval Operations directions. Since this work was done the USS COLE was put back into the water a day ahead of schedule on September 14, 2001 as illustrated in figure 5. After being put back into the water the USS COLE has had all her weapons system and other systems reinstalled. The USS COLE sailed out of Pascagoula, MS on April 20, 2002 to rejoin United States Naval Ships participating in the War on Terrorism. It is hoped that after the events of September 11, 2001 that people in the United States of America never forget about the 19 men and women who died and the heroes who risked their own lives to rescue the injured.

The USS COLE being relaunched in preparation for final outfitting.
(Courtesy of Ingalls Shipbuilding)
Figure 5.
