Highly Advanced M&S System for Marine Accident Cause Investigation using FSI Analysis Technique

Sang-Gab Lee, Jae-Seok Lee, Hwan-Soo Lee

Korea Maritime & Ocean University, Marine Safety Technology

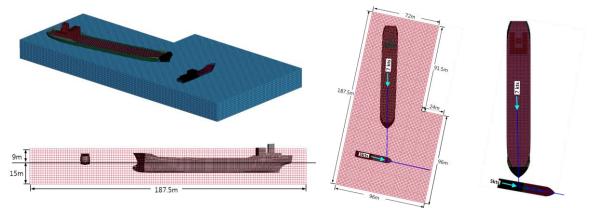
Diverse scenarios were tried, such as collision attack angle, striking and struck ship velocity, for the investigation of collision and capsize accident. In this study, among several scenarios, one collision simulation result, such as collision attack angle 70°, striking and struck ship velocities 7 and 5 knots, were treated, as shown in Fig. 8. For the comparison of simulation results using FSI analysis technique with those of conventional one, full-scale collision simulation was carried in void condition with the consideration of added mass, such as 1.1 times for the striking ship and 1.8 times for the struck one, where collision velocities were initial ones. In this study, mild and high tensile steels were used for the striking and struck ships, as shown in Table 2.

(a) FSI analysis technique

(b) void condition Fig. 8: F.E. mesh configurations of full-scale collision simulation using FSI analysis technique & void condition

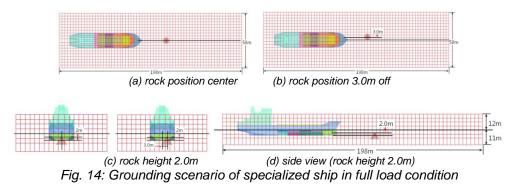
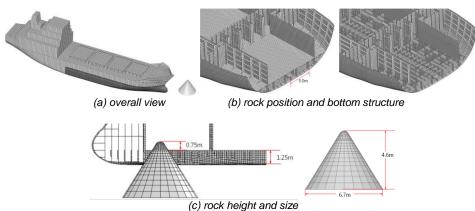
Full-scale grounding simulation of the specialize ship with DWT 2,600 ton was performed for its structural safety assessment using FSI analysis technique and applying propulsion force to ship. Two grounding scenarios were considered for the rock position, such as center at the longitudinal line and 3.0m off the longitudinal one with full load condition. Figure 14 depicts the grounding scenarios, including fluid (seawater & air) model, where fluid model was decided for the enough space of ship motion and fluid boundary pressure reflection. Figure 15 shows the F.E. mesh configurations of the grounding ship and the rock, where bottom structure of the grounding one was modeled by the crushable deformable ones. In this study mild and high tensile steels were used for the specialized ship, as shown in Table 2.

Fig. 15: F.E. configuration of grounding specialized ship and rock
