Test and Analysis Correlation of Foam Impact onto Space Shuttle Wing Leading Edge RCC Panel 8

Abstract

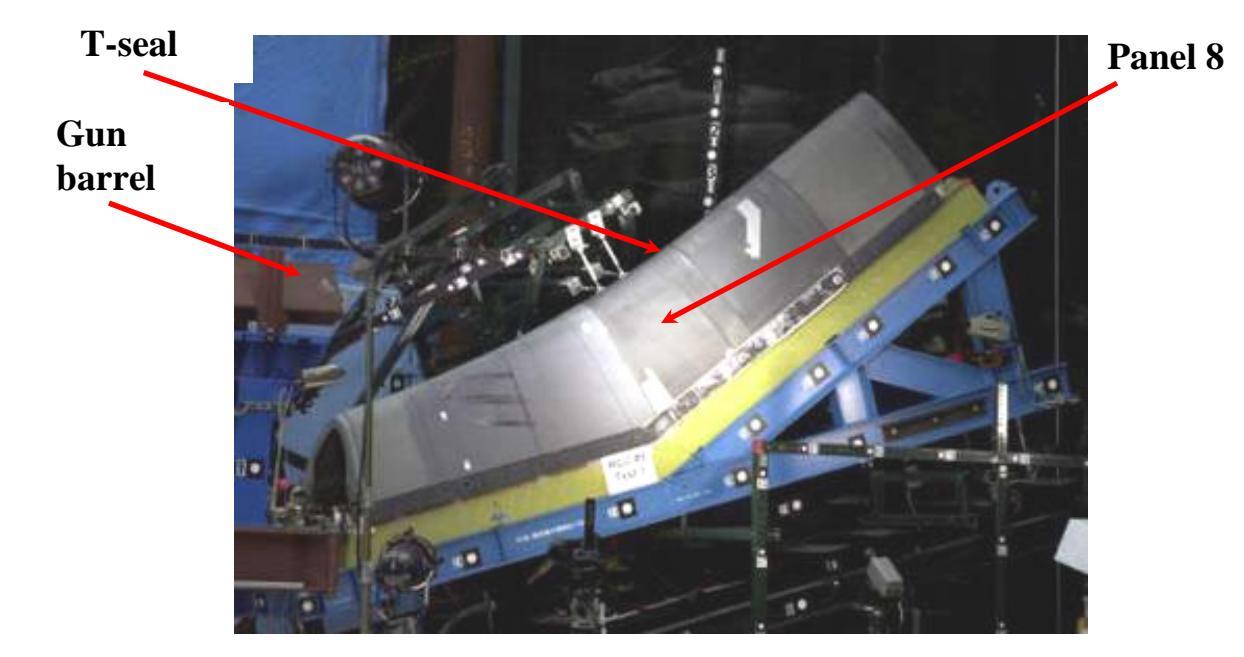
Figure 1. Pre-test set up at SwRI with panels 5 through 10 and associated T-seals on test-rig.

The pre-test setup of panels 5 through 10 with T-seals between panels is shown on the test-rig at SwRI in Figure 1. The end of the gun barrel can also be seen in the figure. The gun barrel was rotated (clocking angle) such that the front edge of the foam would align with the RCC panel to produce as much contact surface as possible. High-speed picture and photogrammetry data were captured as well as time history data from strain-gages and accelerometers.

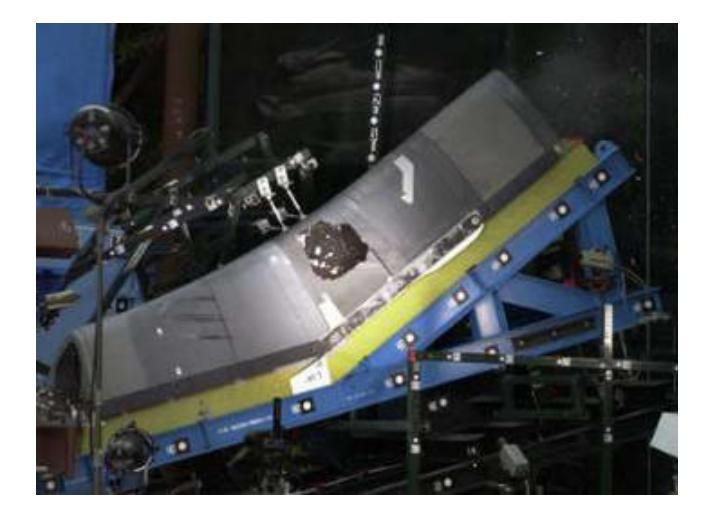
Figure 2. Post-test photo illustrating the large hole in RCC panel 8.

The most obvious result from the test was the large 16-in x 16-in hole in panel 8 that is illustrated in Figures 2 - 3. Also, the RCC fragments from the hole that were created by the foam impact were collected and are illustrated in Figure 4. The ruler at the right side of the figure measures 12 inches in length.

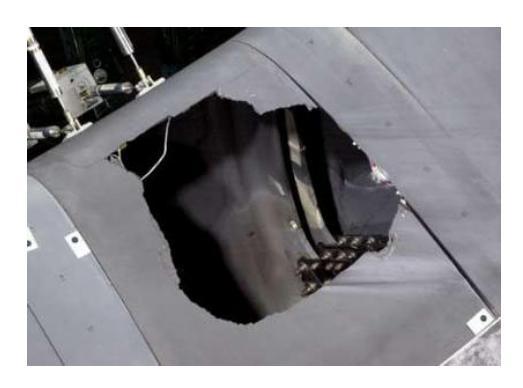
Figure 3. Close-up photograph of the damage to RCC panel 8.

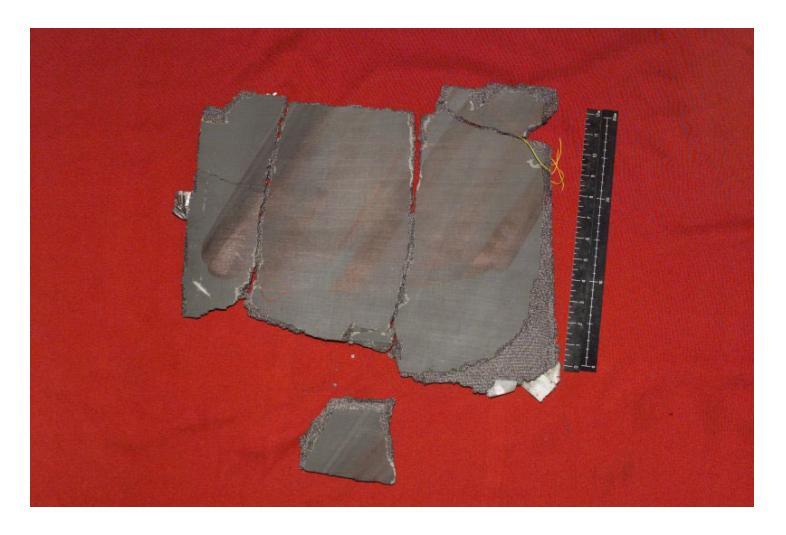
Figure 4. The major RCC fragments from the impact test.

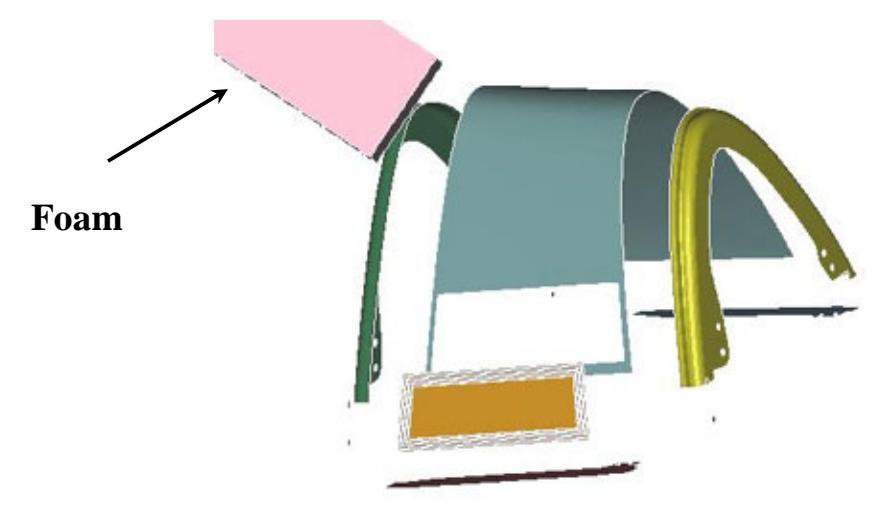
Figure 5. Exploded view of parts of the LS-DYNA model including foam, left and right ribs, front and back flanges or spars, main panel, and front lower doubler region.

An exploded view of the LS-DYNA model is shown in Figure 5. The model consists of a single panel 8 with a foam projectile and neglected the adjacent RCC panels and the T-seals that fill the gaps between RCC panels. There were a total of 25 designated parts in the LS-DYNA model. The model used 59,360 shell elements to represent the RCC panel and 11,636 solid elements to represent the foam projectile. The shells make use of lamination theory and are modeled to have the actual number of plies for each area (part) modeled. The nominal size of the RCC shell elements was chosen to be approximately 0.2 inch on a side. From LS-DYNA parametric studies performed on the RCC Panel 6 impact test conducted in June 2003 at SwRI, the boundary conditions removed from the area of the impact do not significantly affect the damage. Thus, whether the panel is held in place or is completely unrestrained, the predicted damage was about the same. In this panel 8 model, the bolt holes in the flanges were filled with a rigid material that was completely restrained.

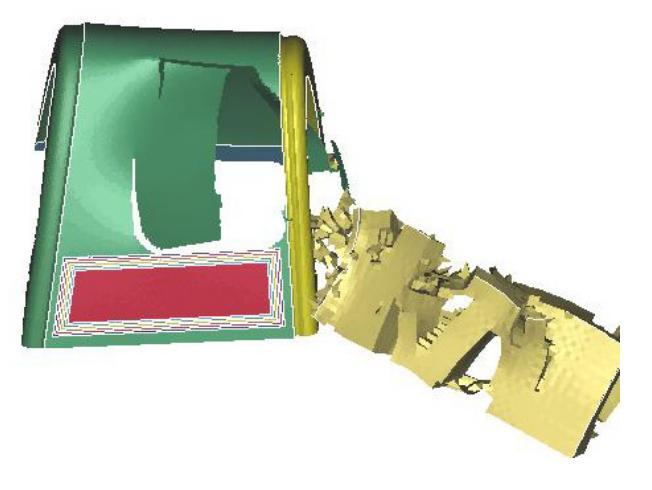
Figure 6. LS-DYNA model showing foam and panel breaking apart 6 ms after impact.

The deformed model at approximately 6 ms after impact is shown in Figure 6. The "picture panel" area (in red) at the bottom of the panel is a doubler region with ply drop-offs forming the "frame." The damage did not extend into the doubler region. Qualitatively, the damage shown in Figure 6 correlated quite well with the size and shape of the actual hole observed post-test (see Figure 3). The RCC debris that was collected post-test is illustrated in Figure 7 from the back side of the panel with the photogrammetric targets. In Figure 8, damage progression is shown at 5 ms after foam impact. The broken pieces in the simulation show a remarkable similarity to the actual pieces collected and shown in Figure 7. Failure of a brittle material is chaotic and depends on local imperfections, residual strains, and thicknesses of the material. The simulation assumes

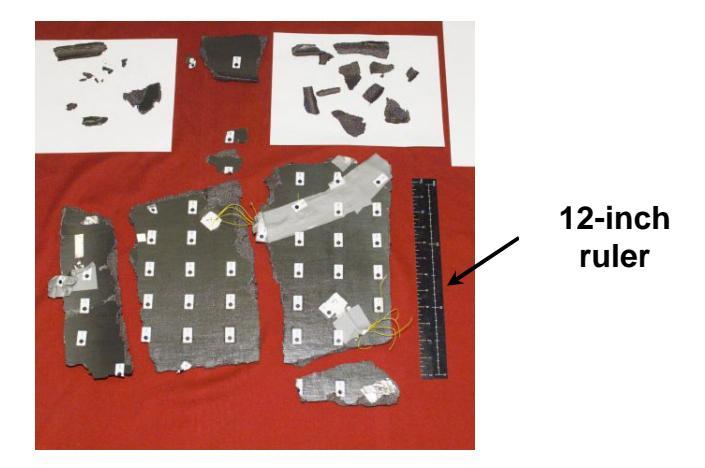
Figure 7. Panel debris showing photogrammetric targets on the back side. The black ruler on the right is 12 inches long.

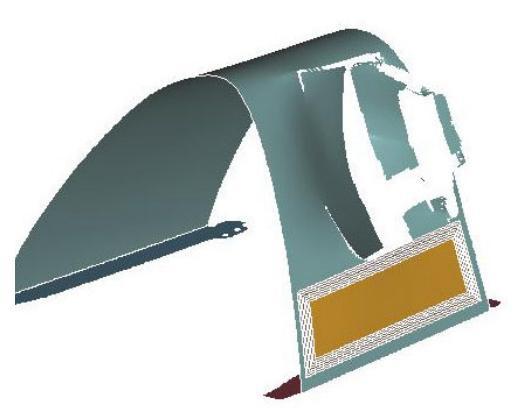
Panel 8. LS-DYNA model, with panel ribs and foam removed for clarity, showing RCC debris pattern at 5 ms after foam impact.

a perfect orthotropic RCC material without imperfections and cannot be expected to accurately predict the actual shapes and sizes of the debris.

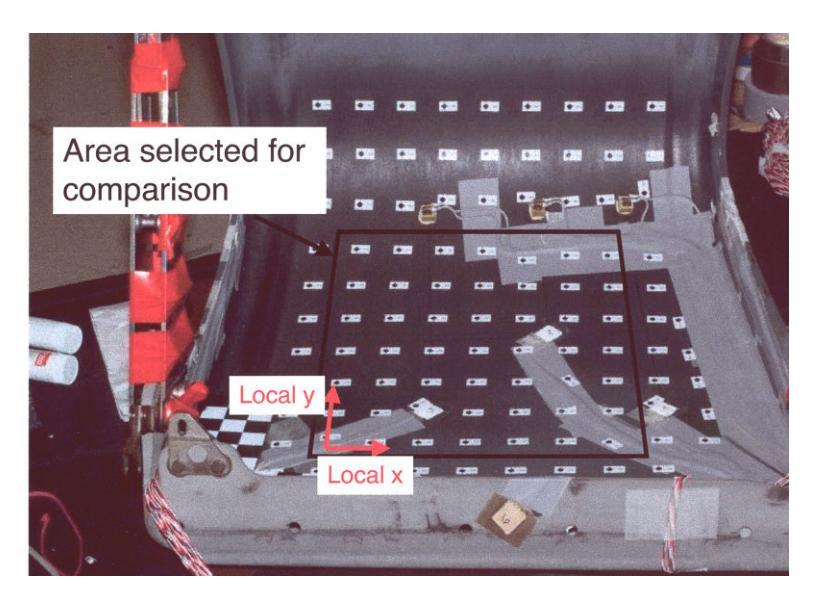
Figure 9. Photogrammetric targets on the back of Panel 8 in the SwRI test.

The displacements of targets on the backside of panel 8 were captured by high-speed video cameras. This photogrammetric data were analyzed in the region outlined by the square in Figure 9. Since the local axis system shown in Figure 9 did not align with the model axes, the photogrammetric data were processed to obtain a resultant displacement at each point for a given time. The resultant displacement is a scalar quantity independent of the coordinate frame. The experimental resultant panel displacements for the points at various times were then plotted as contour plots and compared with the LS-DYNA predicted resultant displacement contours. A typical comparison of test with analysis is shown in Figure 10 for a time of 1.8 ms after foam impact. The panel began to break up around 2.0 ms after foam impact.

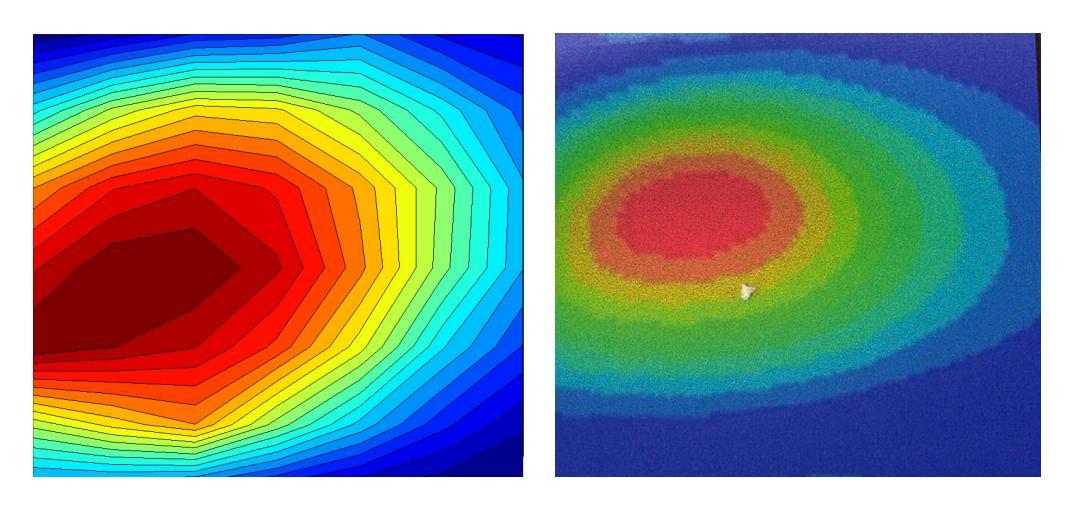
Figure 10. Measured (left) and predicted (right) deflection pattern at 1.8 ms after foam impact. The maximum deflection contour for both plots is 1.2 inches.

The resultant displacement data predicted by LS-DYNA was consistent with the experimental data and produced contours that approximated the overall pattern of deflection for each time interval. Since the experimental photogrammetric method has not been completely validated against a standard, the data should only be considered as qualitative.

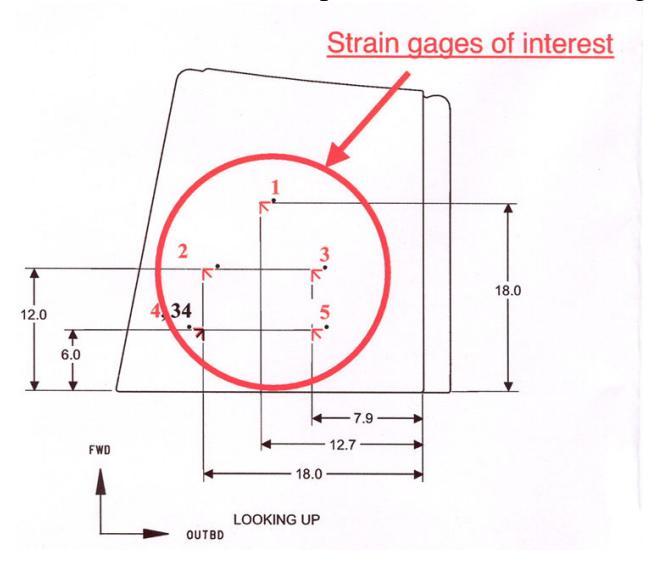
Figure 11. Strain gage locations in test drawing. The strain gages were on the inside of the panel.

A large number of strain gages were placed on the panels, ribs, and flanges for the impact test onto panel 8. The test-analysis correlation presented in this paper will concentrate on the five strain-gage rosettes on panel 8 near the foam contact region. The test data were processed to determine the local-x, or longitudinal strains, and the local-y, or lateral strains (see coordinate system in Figure 9). The five positions of interest of the strain-gage rosettes are shown in Figure 11 and are labeled from 1 to 5. The five elements in the finite element model that best corresponded to the experimental location are shown in Figure 12 labeled with the shell element number. The experimental strains are compared with the predicted strains on the inside (inner or 19^{th} ply) of the selected shell element. The comparisons are shown in Figures 13 through 17.

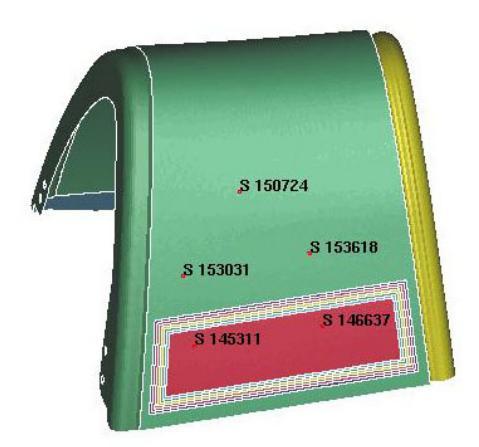
Figure 12. Locations of five elements that best correspond to the strain-gage locations 1 through 5 (see Figure 11).

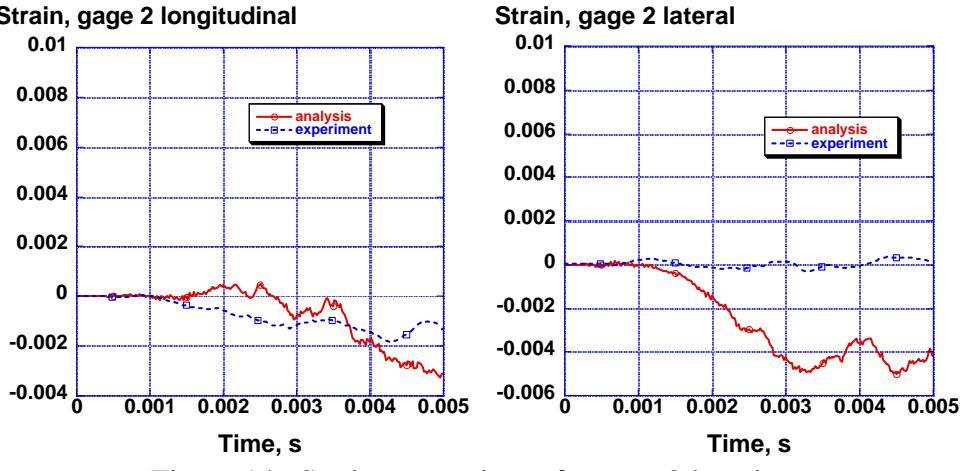
Figure 14. Strain comparisons for gage 2 location.

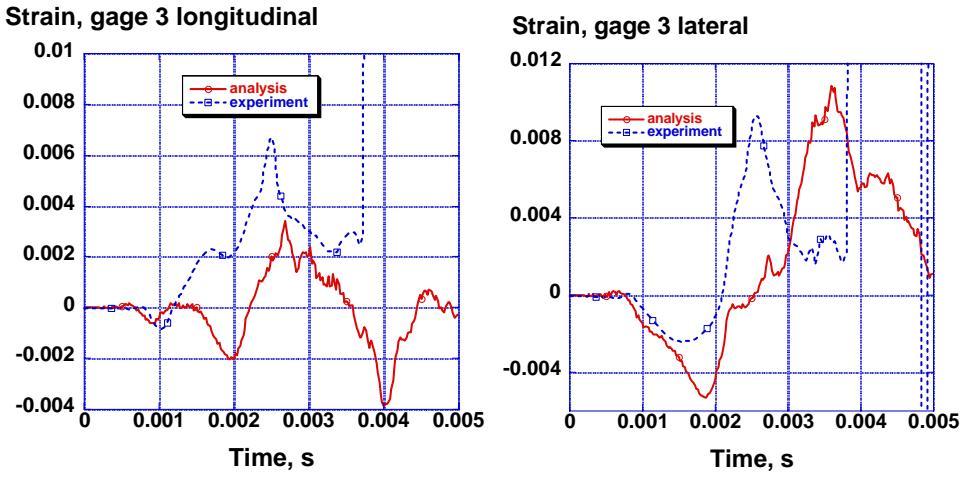
Figure 15. Strain comparisons for gage 3 location.

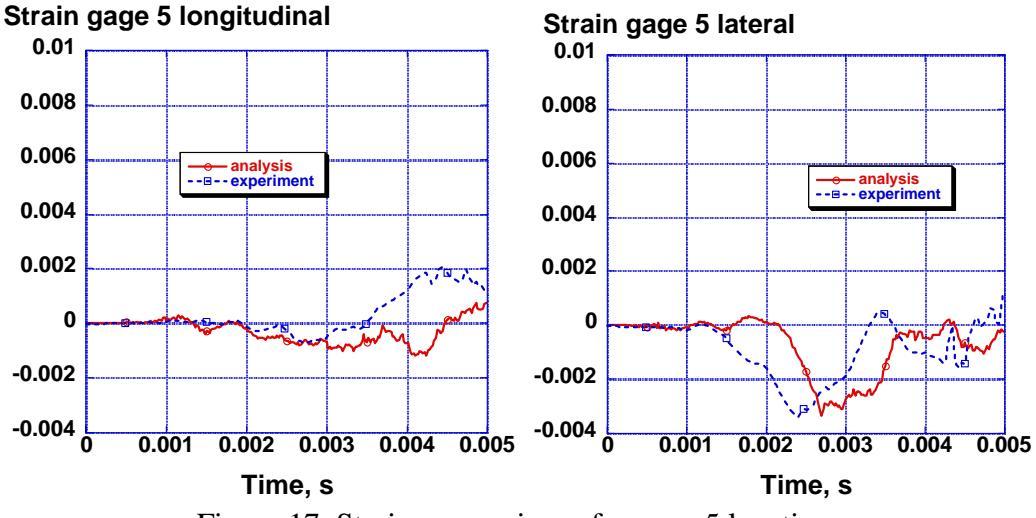
Figure 17. Strain comparisons for gage 5 location.
